Appendix 21-1: Coastal Erosion Assessment Report

ORIEL WIND FARM PROJECT

Environmental Impact Assessment Report
Appendix 21-1: Coastal Erosion Assessment Report

MDR1520B
EIAR – Appendix 21-1
A1 C01
March 2024

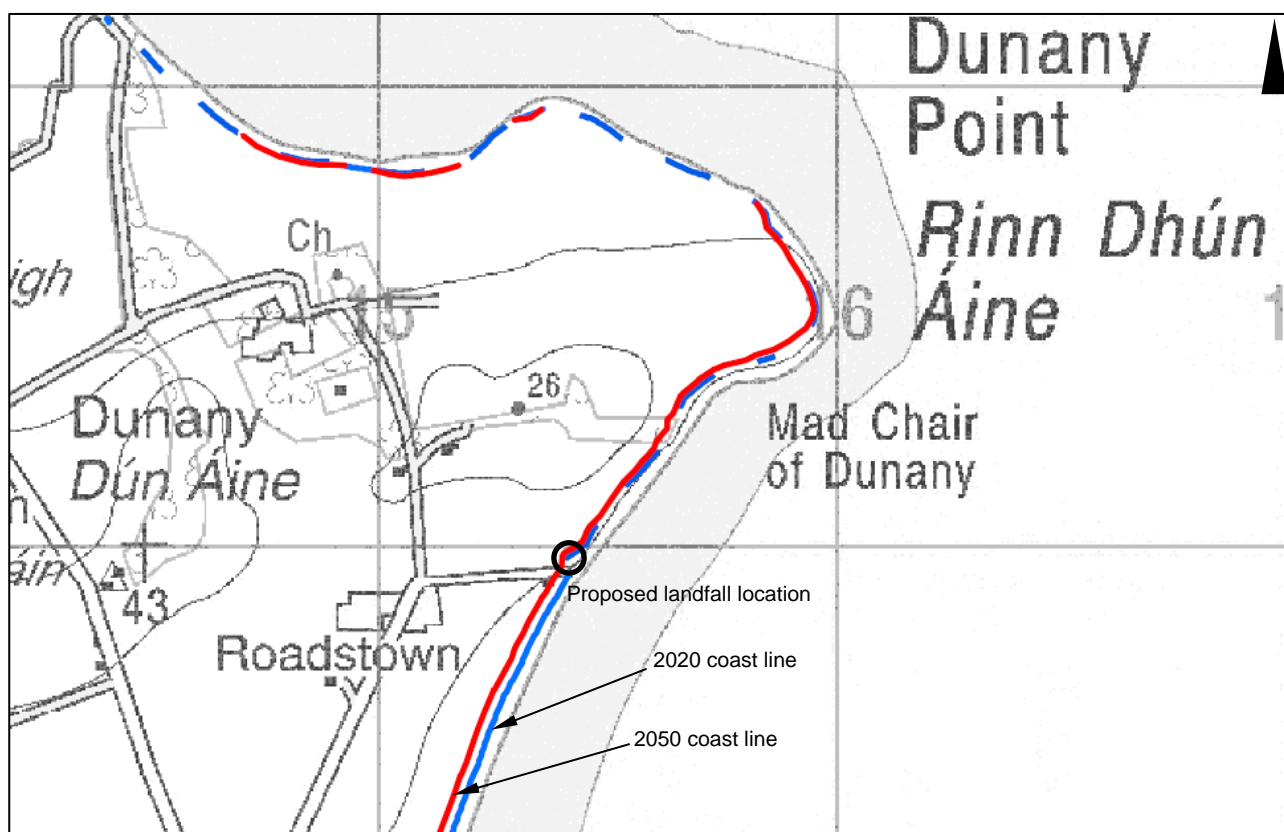
Figure 3-1: Prediction of likely coastline in 2050 (RPS, 2010).

At the landfall location the predictions are considered to have a medium degree of confidence that is between 55 and 70%. The coastal study report at the landfall location indicates some future retreat of the coastline (Figure 3-1) from its current location but the magnitude of that retreat is marginal and considered beyond the of level accuracy of the study to provide an actual measurement. For the purpose of this report, it is assumed that coastal retreat may be in the range of 5 to 10 m by 2050.

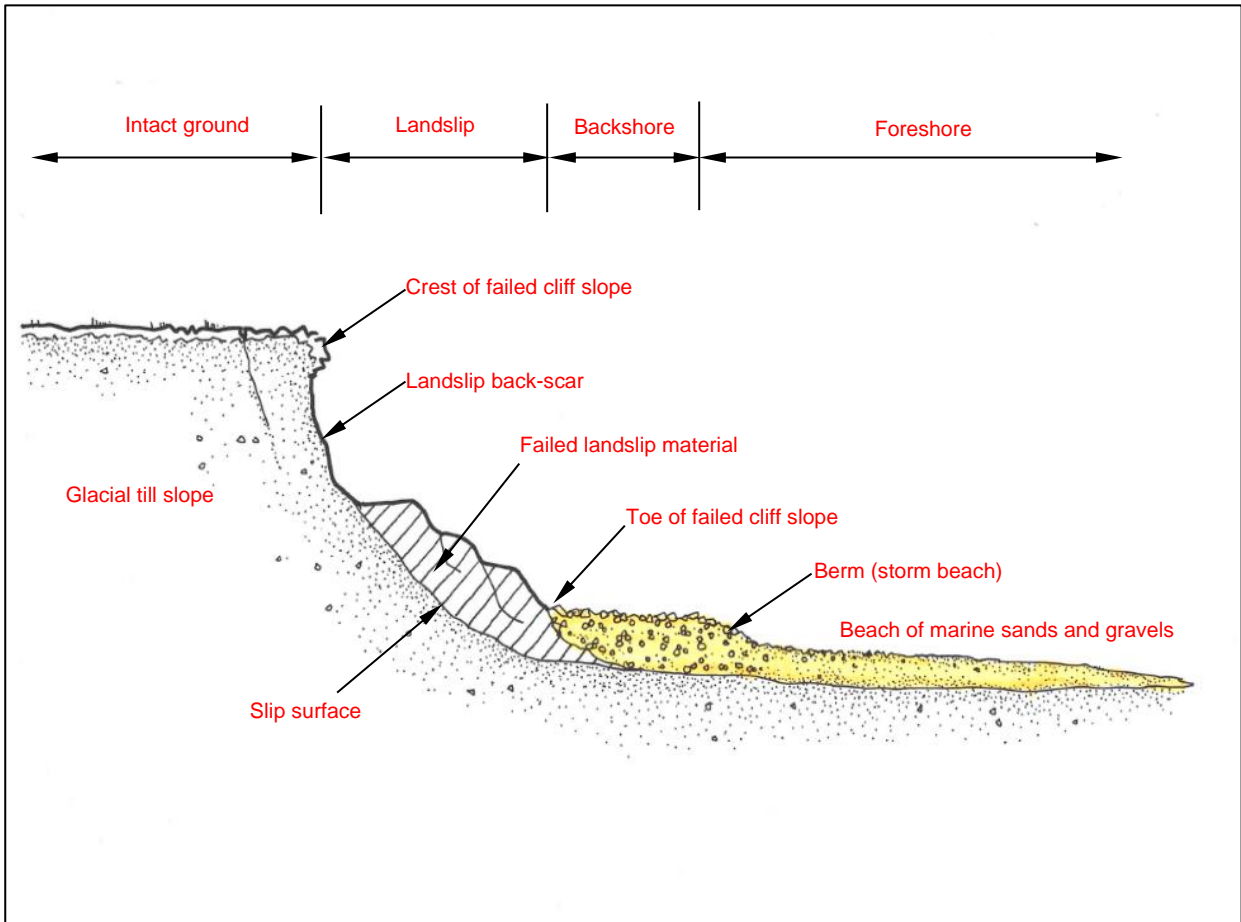
Figure 4-2: Schematic section through cliff slope showing details of landslipping.

5. The landslips along the cliff comprise essentially circular shear failures within the glacial soil. Failed landslip material mantles the lower part of the cliff slope. Wave and scour erosion of the landslip material has occurred to varying amounts along the cliff face (Plate 5), with notably more erosion towards Dunany Point;

6. The wave and scour erosion at the toe of the cliff slope has caused loss of soil material (under-cutting) and loss of strength due to wetting of the lower slope which over time has continued to destabilise the cliff slope;

A schematic showing the details of landslipping along the cliff slope is given in Figure 4-2.

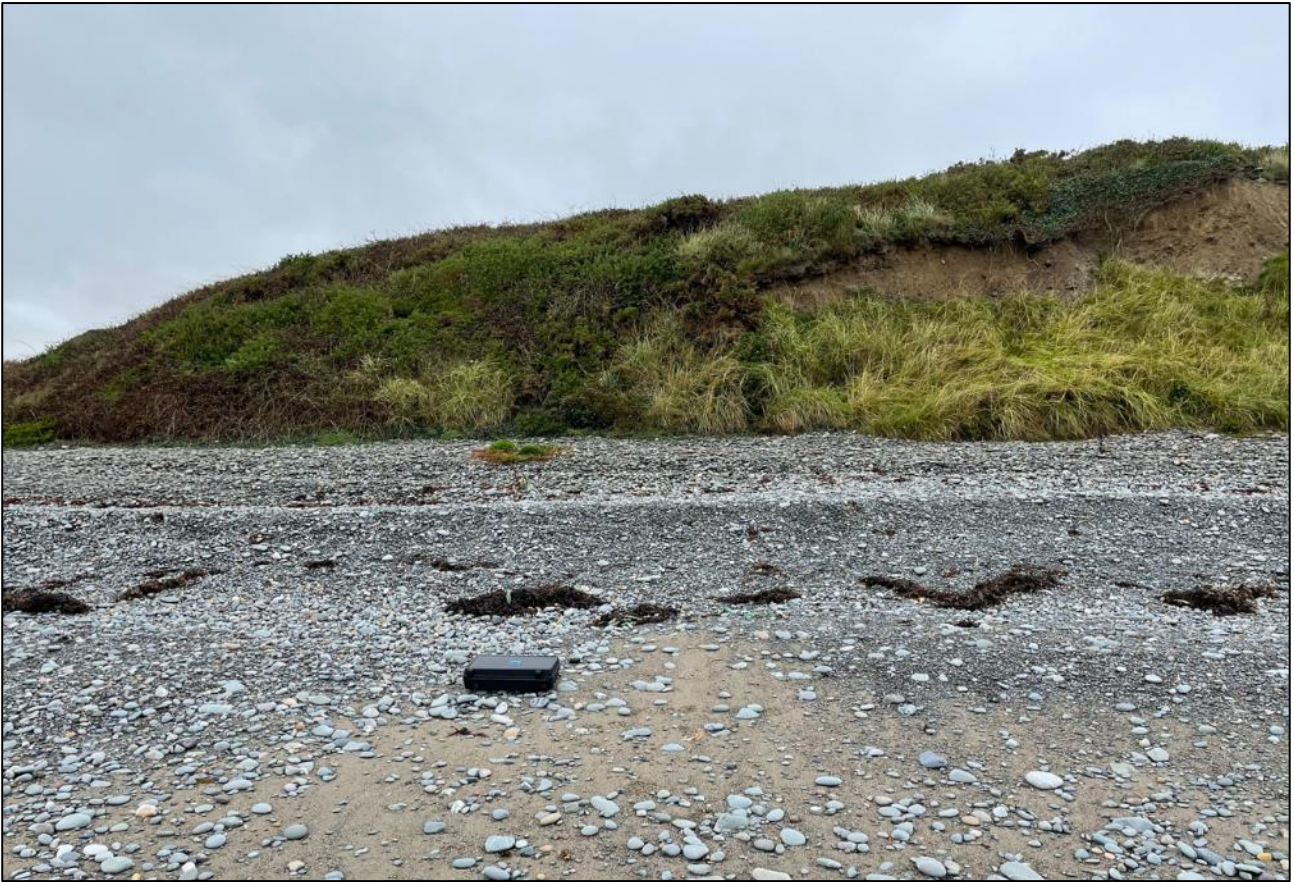
2. The cliff slopes in the area of the landfall and heading north comprises glacial soil which has essentially failed as multiple landslips along the entire length of the coast to Dunany Point (Plate 1 and Plate 2);

Plate 1: General view of cliff slope at landfall location.

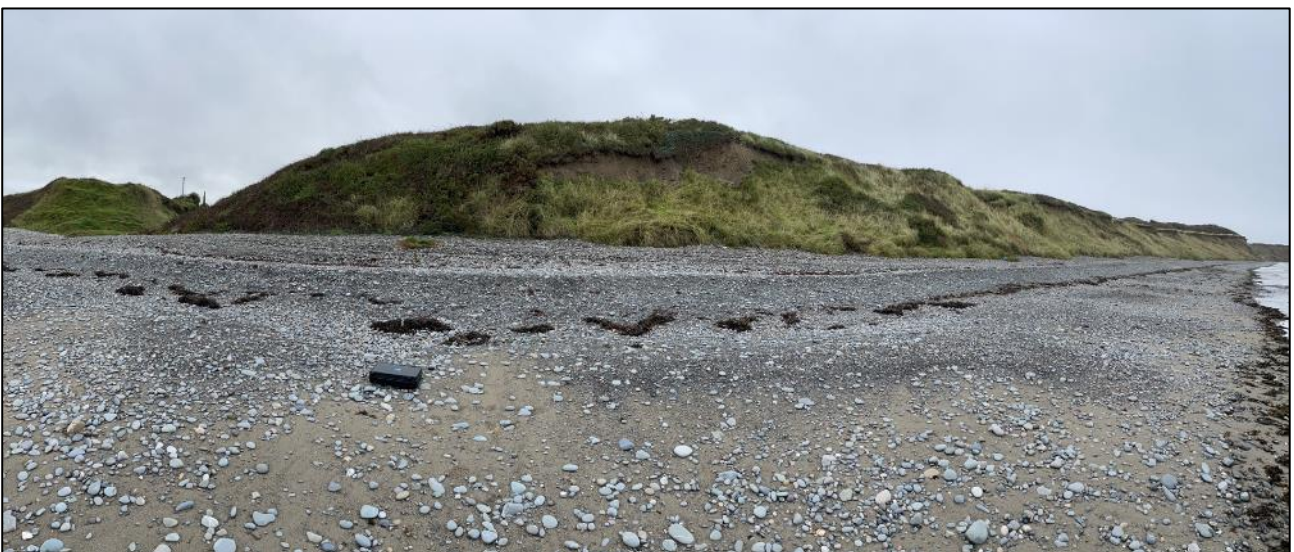
Plate 2: General view of landfall location and cliff slopes to north of landfall location.

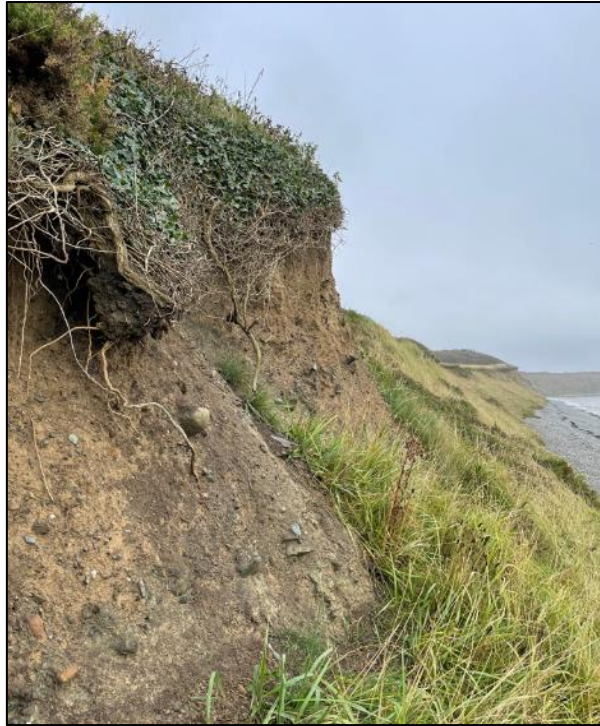
3. The coastal cliff at the landfall location comprises a 6 to 7 m high cliff with an overall slope inclination of about 30° to 50°. The upper part of the cliff is locally steep and approaches about 70°, which corresponds to the back-scarp of a coastal landslip (Plate 3);

Plate 3: Back-scarp of landslide in cliff slope at landfall location.

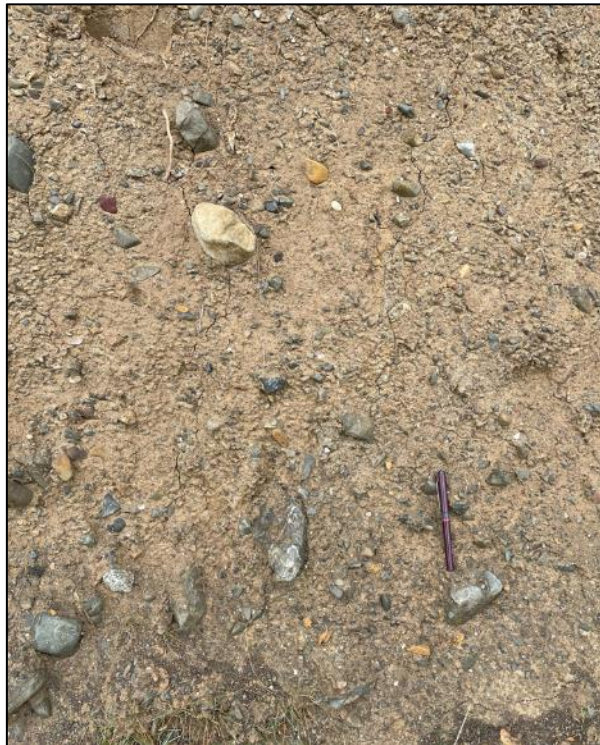
4. Examination of the cliff at the landfall shows that it is composed of dominantly stiff to very stiff brown slightly sandy slightly gravelly silty CLAY with sub-angular to angular gravel and occasional cobbles of mixed lithology. The glacial till (Plate 4) within the cliff is the same material as identified in the boreholes;

Plate 4: Close-up view of exposed glacial till within back-scarp of landslide at landfall location.

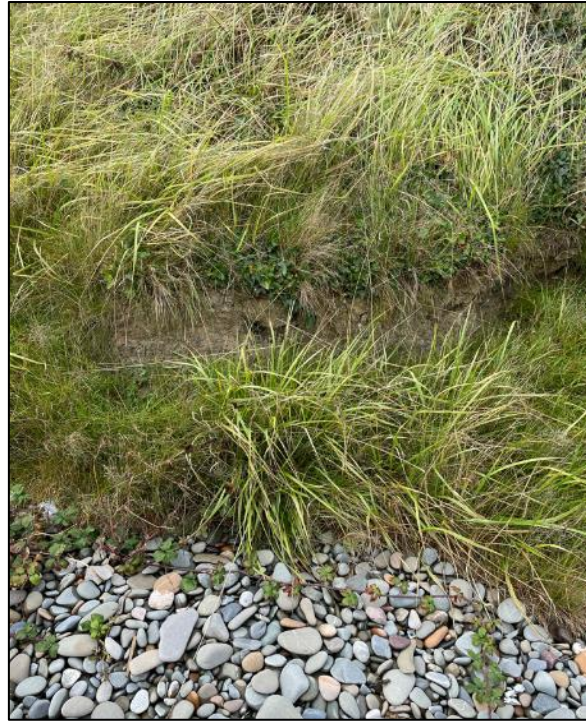
Plate 5: Minor erosion of toe of landslip material at landfall location.

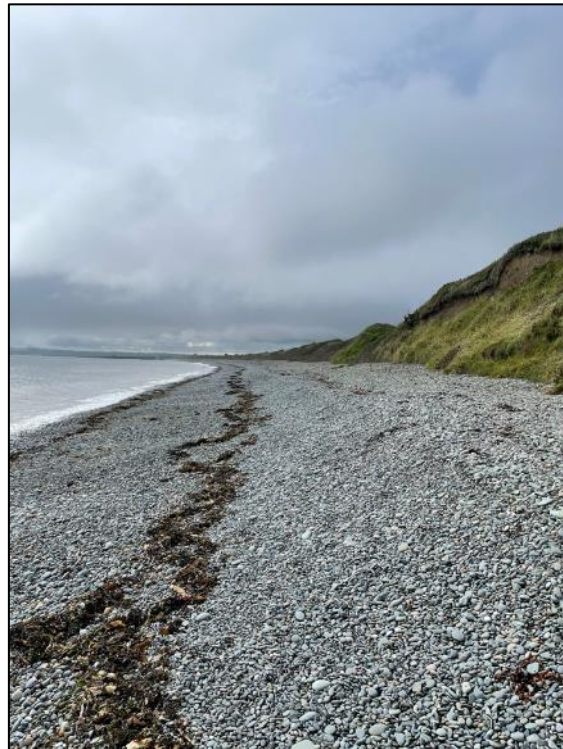
7. Inspection of the beach morphology shows a storm beach (berm) about 3 to 8 m from the cliff toe at the landfall location (Plate 6). The storm beach comprises beach material piled up by wave action during high water (storms). The berm divides the beach into backshore (upslope of berm) and a foreshore (downslope of the berm). The backshore and foreshore beach sections are inclined at about 5° with the separating berm inclined at about 25°;

Plate 6: View south showing storm beach.

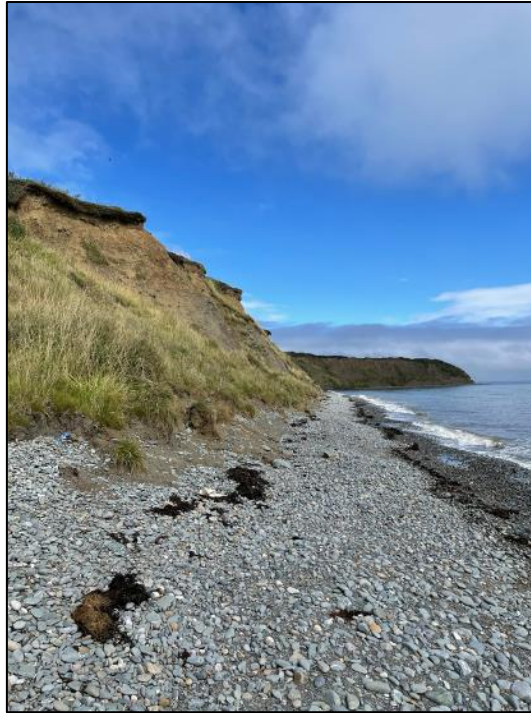
8. It is noted that the storm beach is at a greater distance from the cliff toe at the landfall location but gradually reduces to meet the cliff toe towards Dunany Point, where cliff instability is notably greater and more active (Plate 7 and Plate 8) as a result of exposure to increased wave and scour action at the toe of the slope;

Plate 7: Increase in extent of active landslip in cliff slopes about 0.5 km north of landfall location.

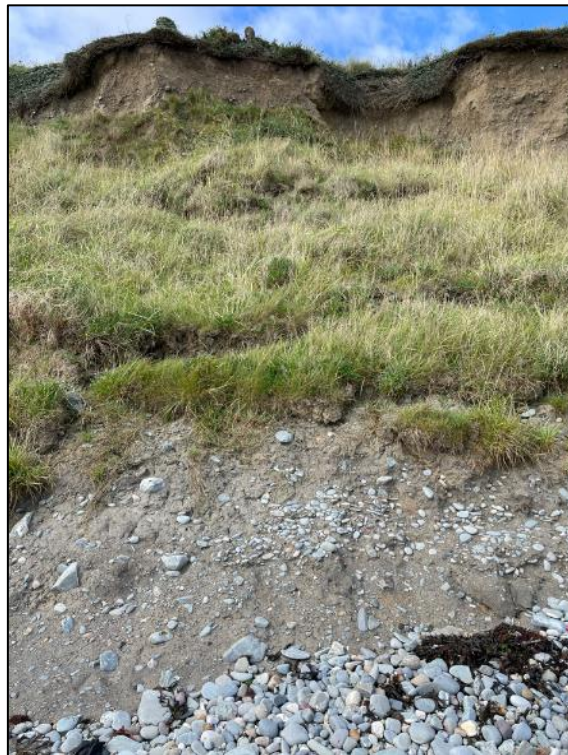
Plate 8: Notable toe erosion in landslip material in cliff slope about 0.5 km north of landfall location.

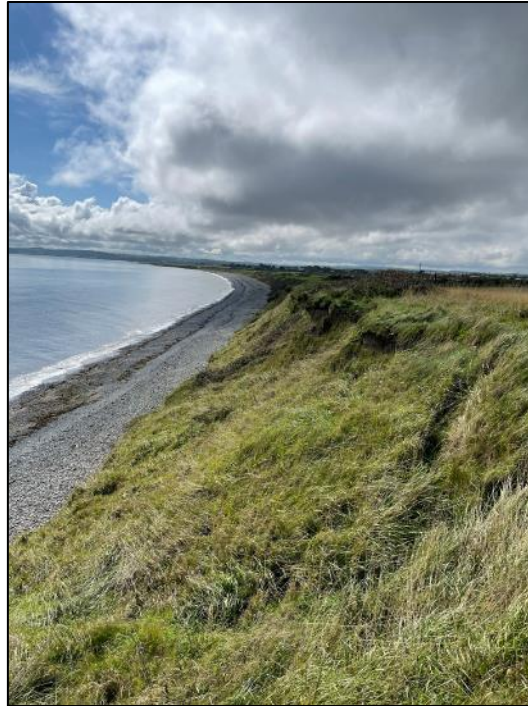
9. The crest of the cliff slopes comprise multiple arcuate scars which represent successive and multiple sequence of landslipping of the cliff slope (Plate 9); and

Plate 9: View south along crest of landslips in cliff slope.
