Appendix 21-1: Coastal Erosion Assessment Report

ORIEL WIND FARM PROJECT

Environmental Impact Assessment Report
Appendix 21-1: Coastal Erosion Assessment Report

MDR1520B
EIAR – Appendix 21-1
A1 C01
March 2024

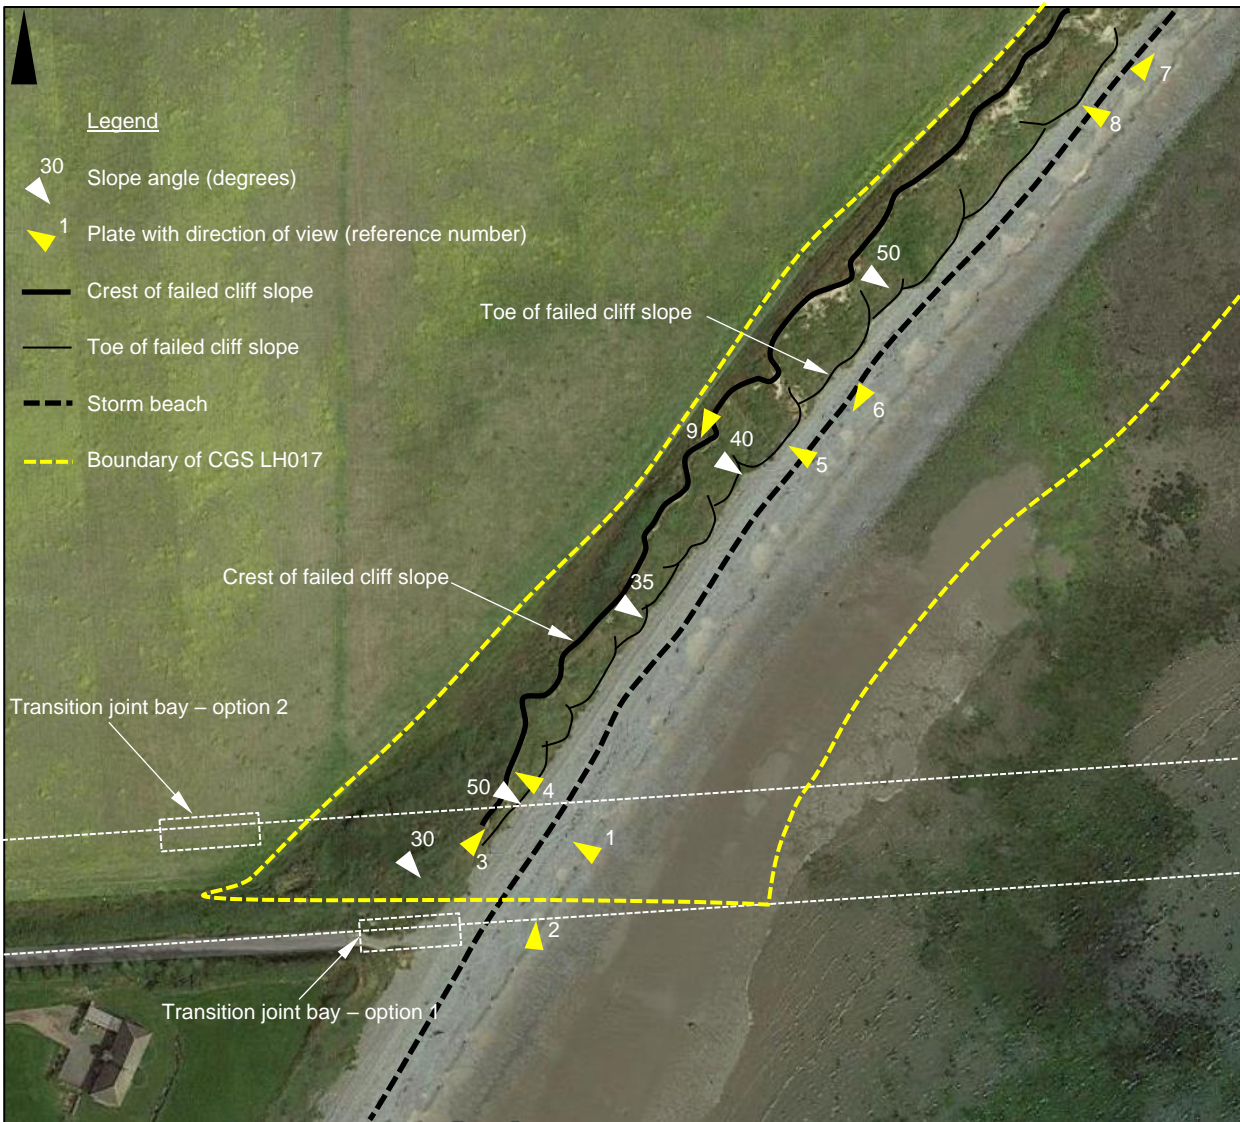
5. The landslips along the cliff comprise essentially circular shear failures within the glacial soil. Failed landslip material mantles the lower part of the cliff slope. Wave and scour erosion of the landslip material has occurred to varying amounts along the cliff face (Plate 5), with notably more erosion towards Dunany Point;

A schematic showing the details of landslipping along the cliff slope is given in Figure 4-2.
